HISTORIC PROPERTY INVENTORY FORM

Site No.: 39 W 65 Grandview High School
Site Name: Historic Grandview Elementary School
Common
Field Recorder: BA/AV
Date Recorded: 7/24/86
Owner's Name: Grandview School 200/116
Street: P.O. Box 10
City/Town: Grandview
County: Yakima
Zip Code: 98930

Grandview High School
Grandview, Washington

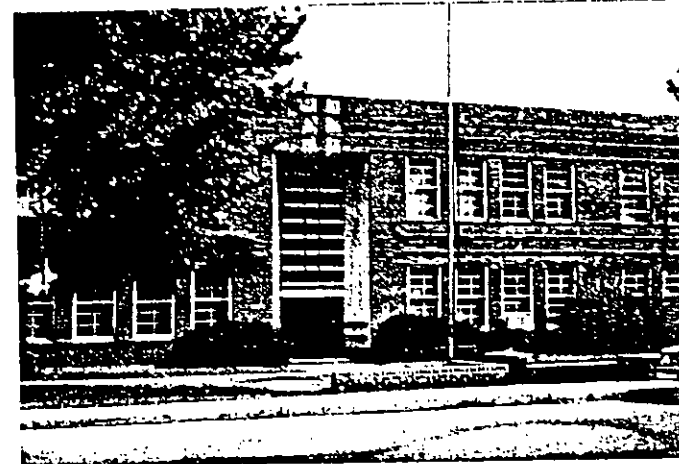
Photography Neg. No.: 4-04
(Roll No. + Frame No.)
View: South
Date: 7/24/86

Grandview High School is a two story, flat roof brick structure with an attached archer gymnasium wing located on a five acre lot west of downtown. The two story building has a structural steel frame and a exterior brick veneer. The plan includes a main east-west wing, with a perpendicular classroom wing on the east and an attached gymnasium on the rear. The facade is dominated by a two story recessed entry bay faced in glass block (to light the interior stairwell) and decorative brick. Above the bay are six carved stone panels representing educational themes. Adding to the streamlined quality of the design, the building is ornamented with several courses of raised brick between the first and second stories and at the cornice level. Large wood sash double hung windows are disposed across the facade and are mostly original. The gymnasium has a vaulted roof with pilasters

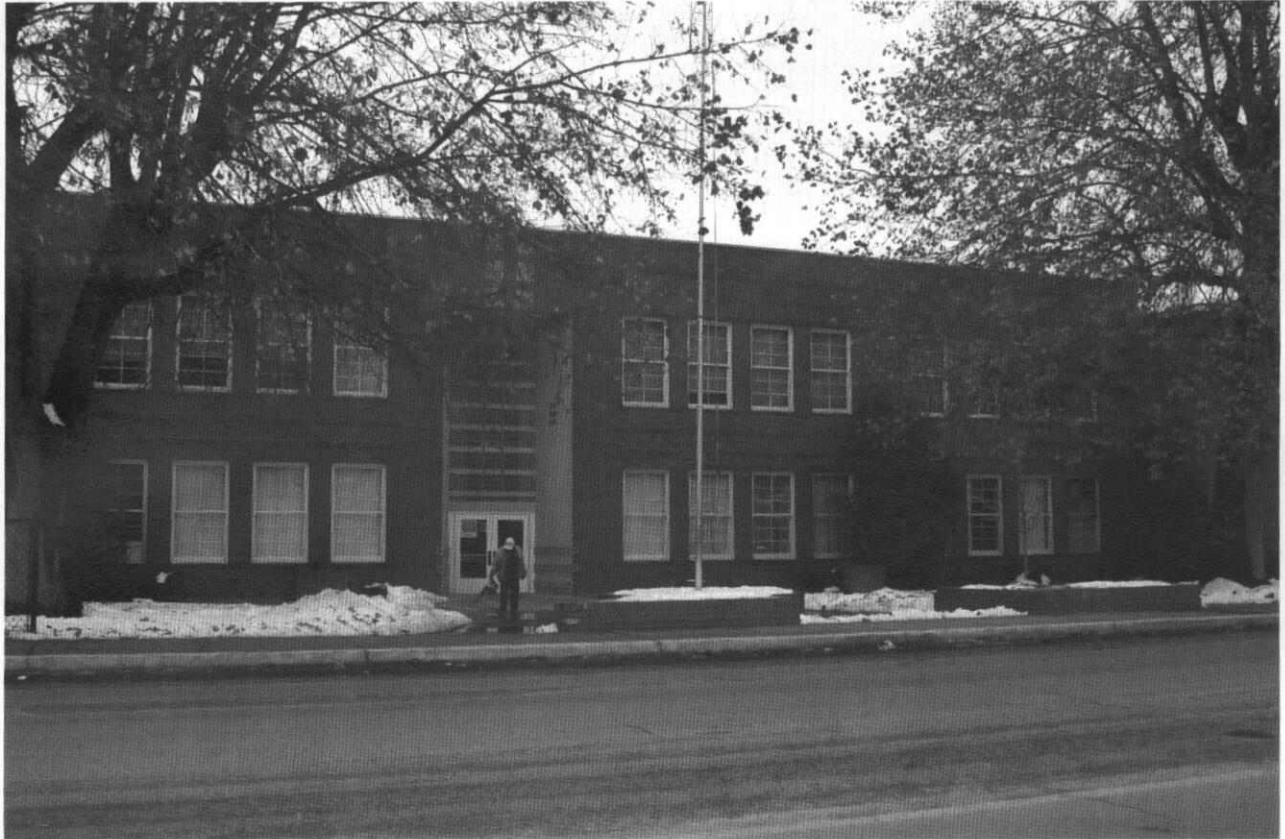
randview High School
randview, Washington

Photographer: Katie Dutcher
Taken: September 3, 1986
Negative: OAHP, Olympia, Wa.
Looking Southeast
2 (Roll 8, #8) 3 of 3
